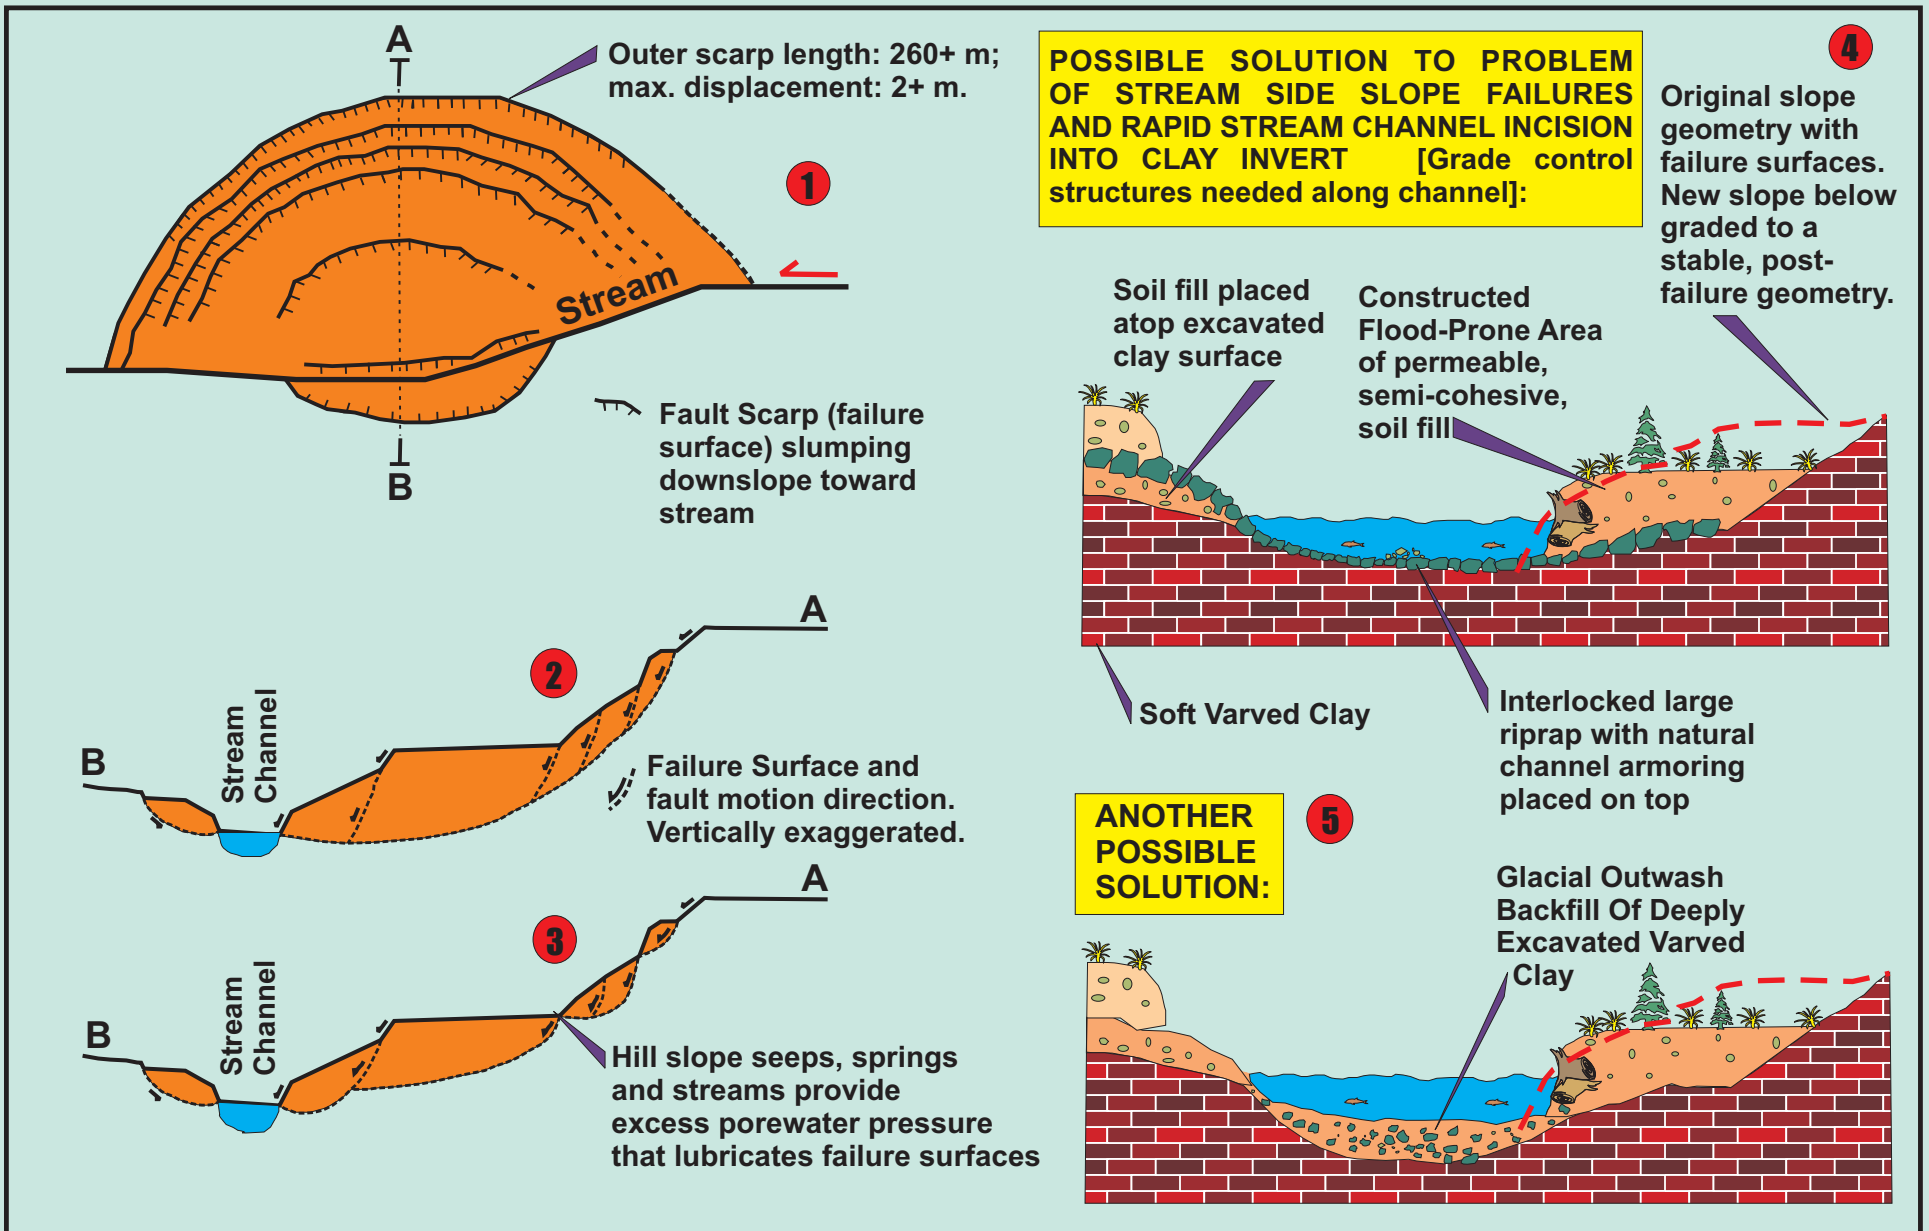
Buildings on or near steep slopes and streams may be at risk of structural failure. Schematic example of stream bank failure in New York State. (1) Areal view of stream side soil failure zone [a gravitational collapse structure]; (2) Cross-section depicting most likely fault geometry consistent with areally and vertically extensive scarp displacement; (3) Alternate shallow focus fault scarp interpretation; (4) & (5) Possible means of eliminating soft clay entrainment along stream. [P. Rubin]
